Restoration Report

Burnt Island Light Station

Summer 2020

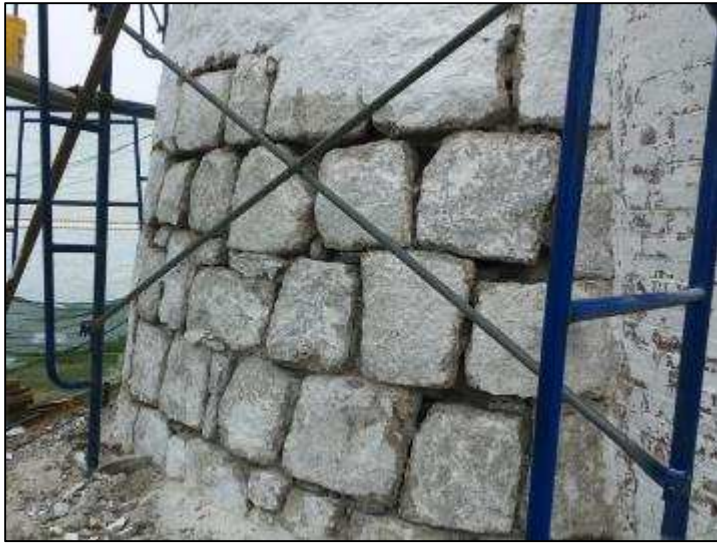
Mortar from Different Periods

Both Portland and natural cement were found in the joints, an indication that the tower had been repointed at an earlier date. After analyzing the mortar's composition and brittleness, Jim Leslie estimated that a repointing occurred around 1920. The 1821 beige-colored mortar beneath the outer, gray cement was firm but it crumbled like sandstone.

Beige Mortar (1821) Gray Mortar (circa 1920)

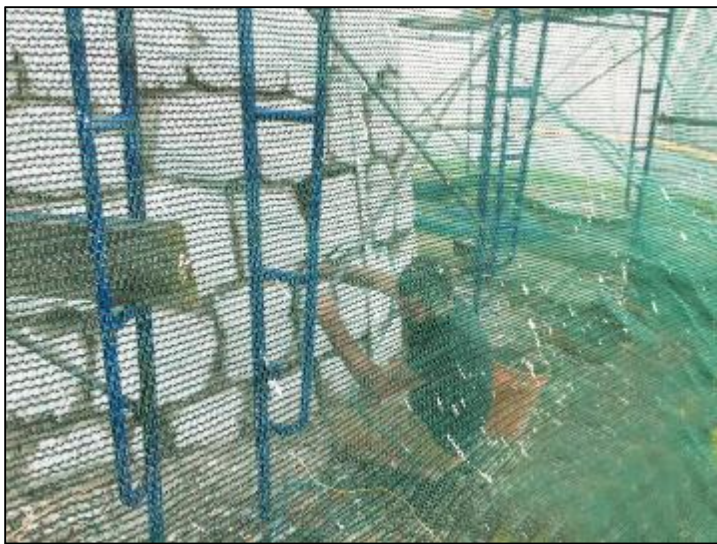
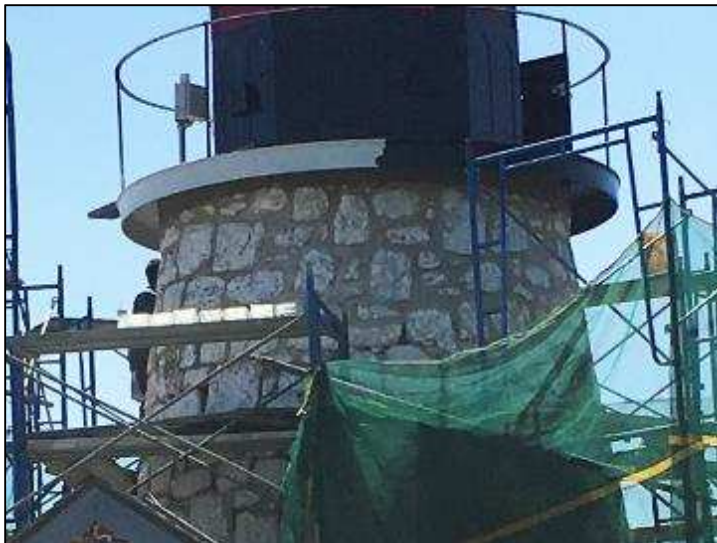
Holes and gaps between some of the granite blocks were filled with additional rubble and Portland cement used to secure them in place. Large holes like pictured below provided a view of its middle layer which consisted of beach stones cemented together.

Due to its ability to breathe, natural cement was used to tuck-point all joints between granite blocks. This repointing process restored the physical and structural integrity of the masonry lighthouse.

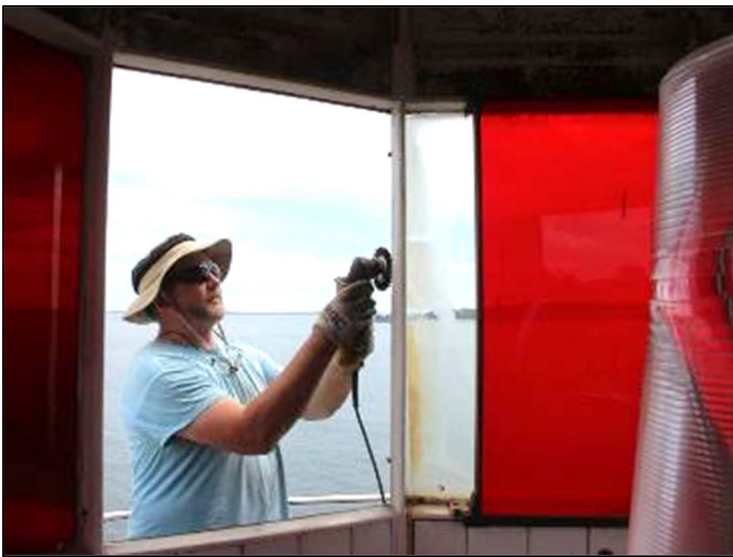
The lantern's ten windows were comprised of two clear glass, four historic red glass, and four red plexiglass panels. The original plan was to replace the plexiglass panels with red glass, but unfortunately that didn't happen. Jim Leslie called several glass companies to secure a product that would meet the USCG's color and clarity standards. The three samples subjected to the LED lamp test (Burnt Island's future upgrade) failed after having produced light of unacceptable colors. To keep the project moving forward, the Coast Guard's offer to replace the crazed plexiglass panels at no cost was the best option as countless hours were spent on this venture.

Cracks in two of the historic, red glass panes were stabilized using JB Weld glass and windshield repair epoxy. Clear plexiglass liners have been cut to protect these panes, but attachment method has yet to be addressed.

All old caulking was cut out and metal astragals removed to access window panels. Several of the astragal's screws were damaged or rusted, so they were drilled out and replaced with stainless ones, while those reused were cleaned and repainted.

Once windows were removed, glass pockets and glass stops were sanded and wire-brushed to clean off dirt and rust. All rusted surfaces were treated with OSPHO rust converter, Kem Bond HS primer and black Corothane paint.

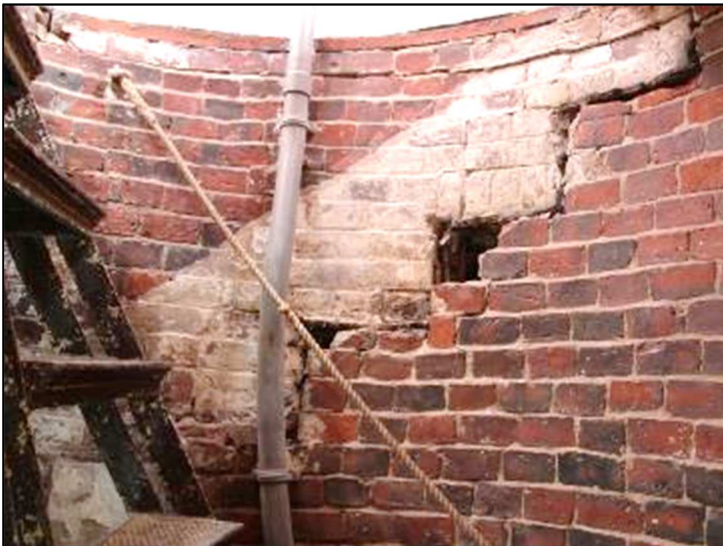
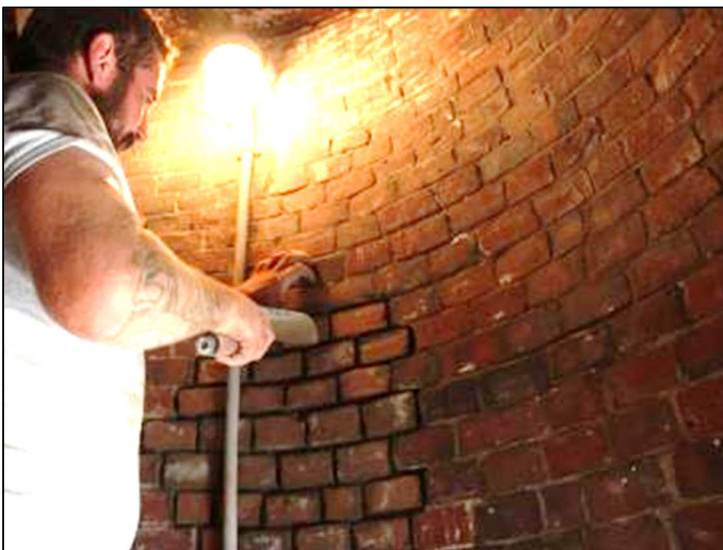
At the base of the tower, the brick liner was in very good condition with minor repointing needed in places where a metal staircase once attached. The present spiral stairs are self-standing with a few attachment rods securing it to the wall at regular intervals. The center drop tube was painted gray as were the top and bottom surfaces of each step.

Repairs to the brick liner were needed towards the top of the tower where two, large, cement patches covered the problems. Once removed, remnants of the old, metal stairs were found as were holes created by sector board attachment. New bricks were mortared in place to seal holes, but uncovered stair pieces were left exposed to highlight these features of earlier construction.

In 1982, when the white sector boards were removed, the brick liner was damaged at their attachment points. As part of the restoration project, similar bricks were cut and mortared in place at those sites. (bottom left photo)

Masonry work also took place at the junction where the lantern rests on the top of the tower. The areas around support beams were reinforced and the top three courses of bricks repointed. These much-needed repairs will help stabilize this interface.

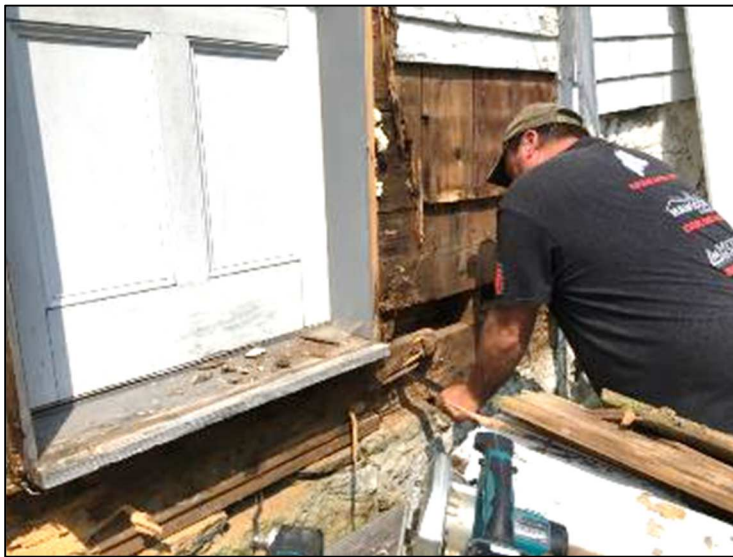
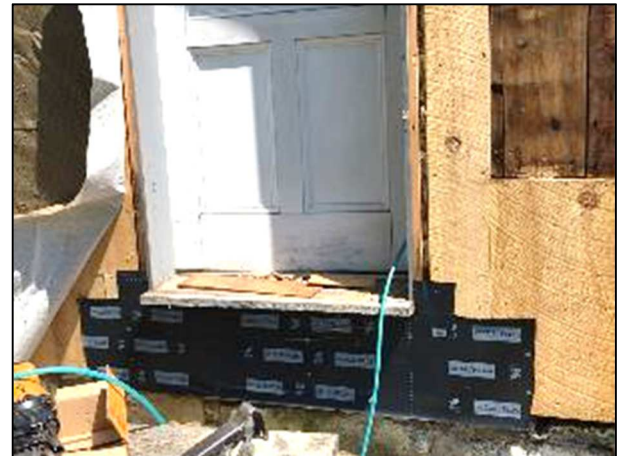
Unfortunately, after siding was removed, rotten sills were found under doorways, the mudroom and the covered walkway. This was understandable due to age and wet environmental conditions, but these repair needs were unknown when the contract was signed. Therefore, the contract was amended to use contingency funding and extend the end date.

All rotten door sills were cut out from under the three doors and replaced, as were any deteriorated wall boards. Covered walkway repairs will be reported in a section to follow as that work was extensive.

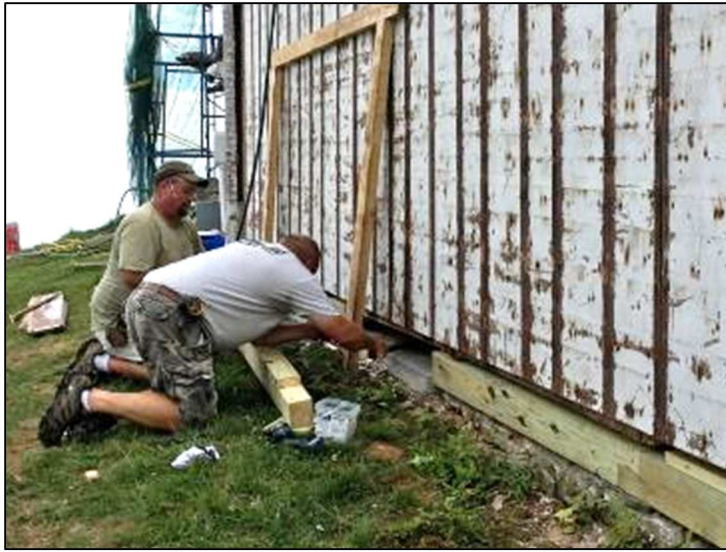
The covered walkway's double sill system was in poor shape with a good 20+ feet of the original sills and floor joists rotted due to direct contact with the ground and runoff water. A cement curb was poured for the new, pressure treated, outer sill pictured above.

In order to access the rotted, inner sill system and floor joists, the Douglas Fir floor pictured below was carefully lifted with every board numbered so that carpenters could return each to their original place. Fortunately, the square-headed nails were rusted, so the planks were easily lifted without damage.

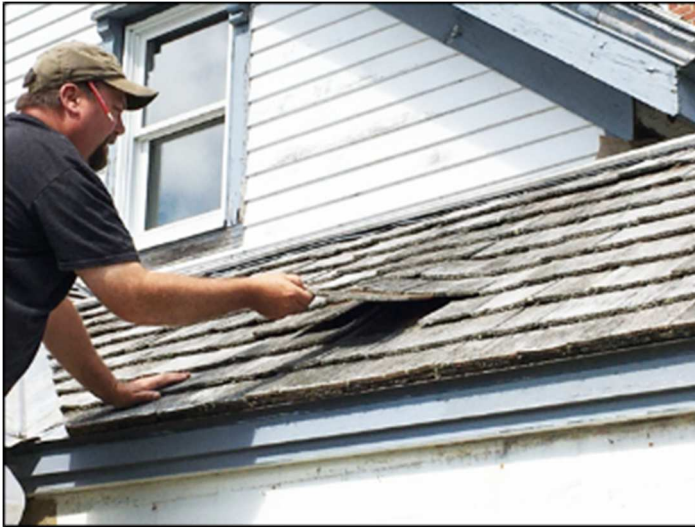
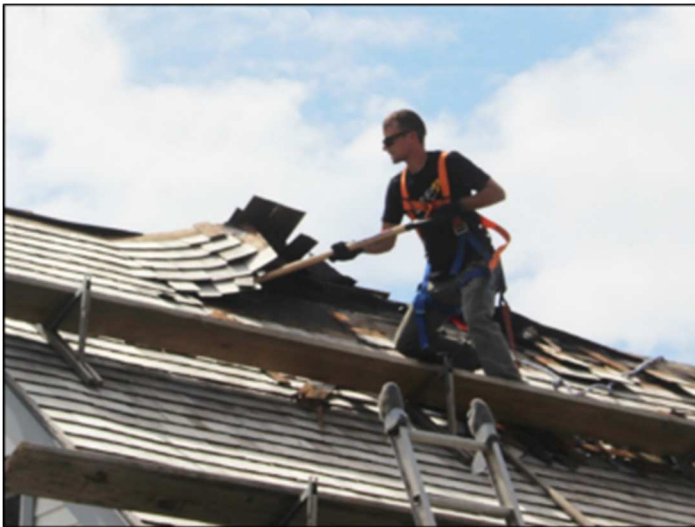
In the early stages of the restoration project, another surprise surfaced when the condition of fascia and trim boards were being assessed. Lead carpenter Marc Holbrook discovered that the roofing shingles were being held on by a thread. Attached with galvanized nails in 2000, the nails holding the white, cedar shingles in place had rusted off. As a result, new roofs had to be included with a change order providing a time extension and the use of the contract's contingency funds for labor, while KBIL paid for all the materials.

Approved for this project was an upgrade in materials to premium Alaskan yellow cedar shingles - 18" long and 5/8" butt. Prior to installation, 40 mil Grace Ice & Water Shield was adhered to the roof boards, topped by CedAir-Mat, a ventilation product used to create an airspace/cavity for air flow. Bostitch 6D, 2" ring shank, 316 stainless nails were used to attach the shingles with 5" exposure. A 2.67" strip of GAF zinc moss and mildew preventer was positioned under the 1"x 6" clear, vertical grain, red cedar, roof cap.

After removing the ridge cap, workers used roofing shovels to lift off the cedar shingles. The sections replaced in front were main roof, porch, ell, and entryway. A one-piece, cedar gutter was replaced along the main roof, while the porch gutter was refurbished as were the two wooden downspouts.
