Restoration Report

Burnt Island Light Station

Summer 2020

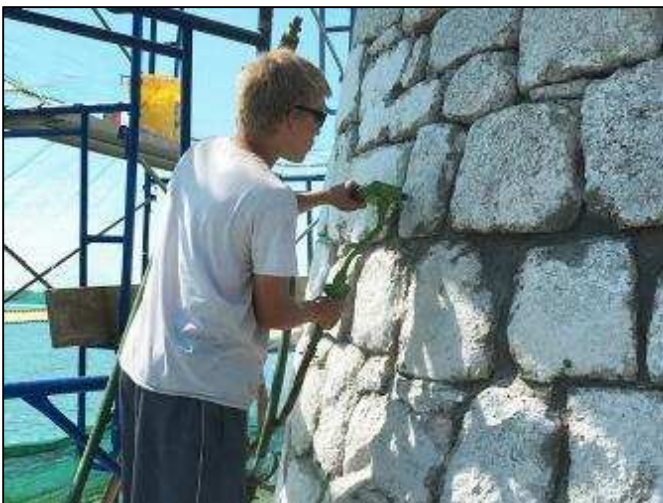
Surrounded by saltwater and exposed to the harshest weather, the tower's blocks and mortared joints were coated for protection. Therefore, the first step in the restoration process was to remove layers of paint, Thoroseal, and whitewash. A tool called a scabblor, pictured at left, removed the tough, outer covering from the granite blocks. Hand and pneumatic chisels were then used to remove old mortar from between the stones to a depth of at least 1.5 inches.

Both Portland and natural cement were found in the joints, an indication that the tower had been repointed at an earlier date. After analyzing the mortar's composition and brittleness, Jim Leslie estimated that a repointing occurred around 1920. The 1821 beige-colored mortar beneath the outer, gray cement was firm but it crumbled like sandstone.

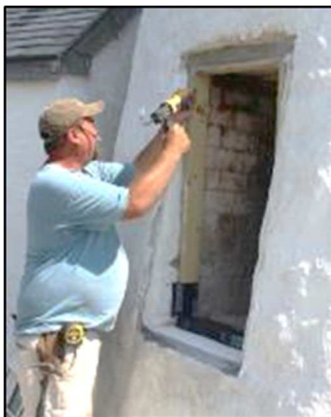
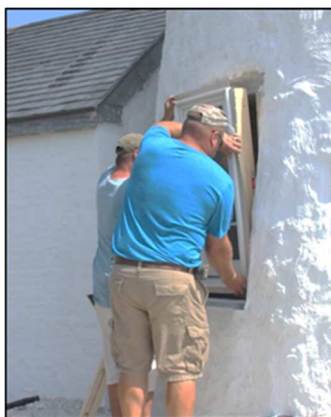
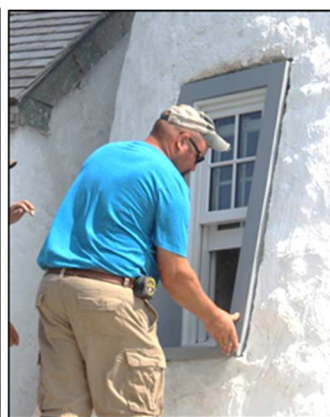
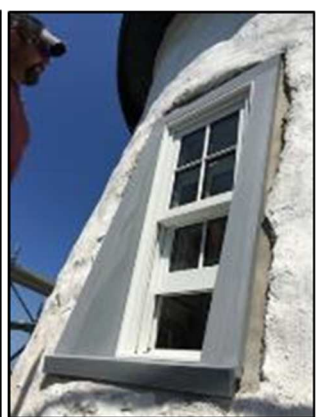
Originally, the tower had two, double-hung, 4 over 4, true divided light windows. It is possible that at automation in 1988, the USCG replaced each with decorative, glass blocks that included a built-in vent.

The installation of new Marvin windows required cooperation between the masons and carpenters because of the wood to concrete interface. Pressure treated wooden frames were built by the Marden crew to receive the windows, while the Leslie crew filled all irregular surfaces with cement to create smooth, water-tight edges. After curing, the frame was screwed into the masonry and all perimeter edges caulked. An Ice and water shield membrane was secured under each window prior to its installation and then tapered trim boards were applied and painted gray. After installation, stucco was used to fill gaps between the tower and trim boards.

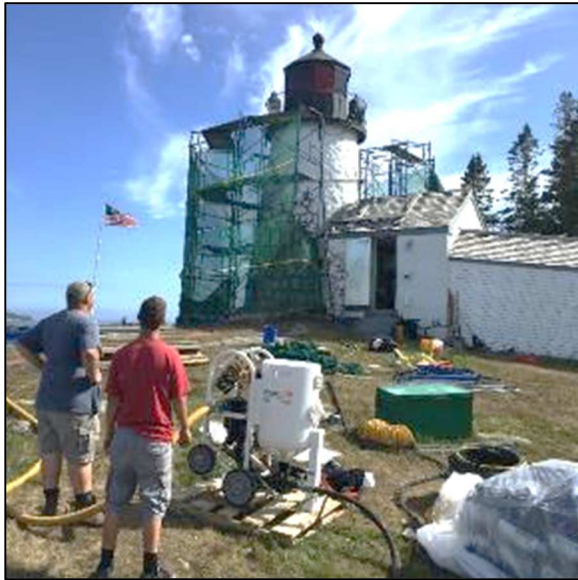
After 199 years, the masonry tower was found to be structurally sound, but it was high time to repoint the joints. Large holes created by missing rubblestone and attached sector boards were areas of concern for water infiltration. The return of real windows to the lighthouse made a huge difference. It now resembles its 1950 appearance, minus sector boards that will never return due to navigational equipment upgrades by the USCG.

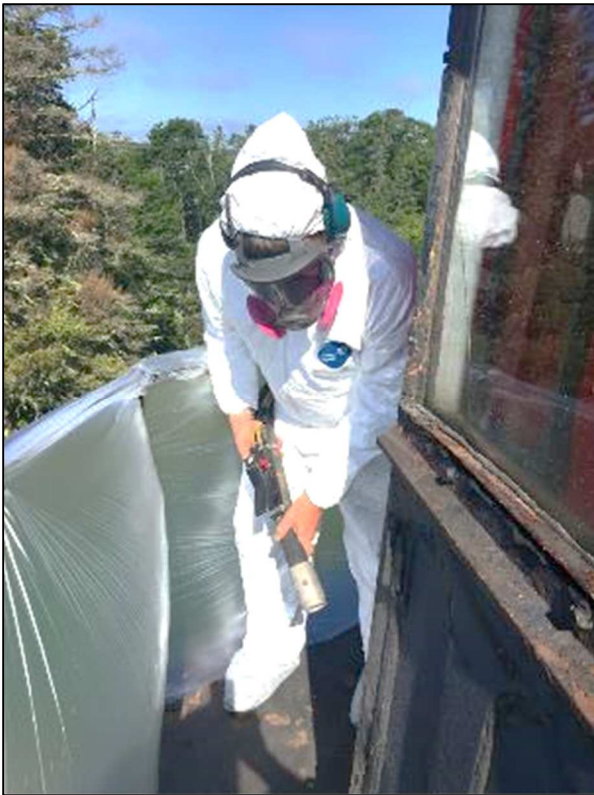
Around 1857, Burnt Island's stone tower was retrofitted with a new lantern as the older one could not support the installation of its new Fresnel lens. Since then, this cast-iron structure has been directly exposed to the elements, and since automation in 1988, maintenance has not been provided. Therefore, its roof and deck were severely rusted, and walls, railing, astragals, and ventilator ball moderately corroded.

J.B. Leslie's method to address the rusted metal in the least abrasive fashion was through use of a tool called a Sponge Jet. Tiny pieces of sponge were propelled at high pressure to remove rust from surfaces without eroding them. He rented the equipment from Sponge Jet of Newington, NH. (www.spongejet.com)

The operator of the sponge-blaster wore a protective suit, respirator, and ear protection. Plastic was attached to contain used media so that it could be cleaned and recycled. Pressure for propelling the media was controlled by the operator, thus allowing for precise removal of rust without damaging the metal.

A pneumatic needle-gun was used as the rust removal tool on the balcony's underside due to extensive corrosion. In more delicate situations like window astragals they were removed and cleaned by hand.

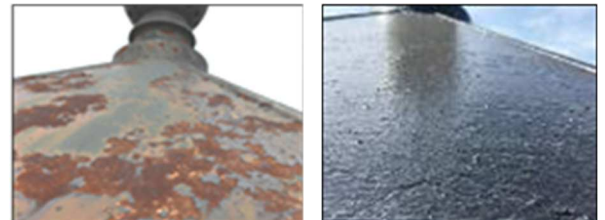
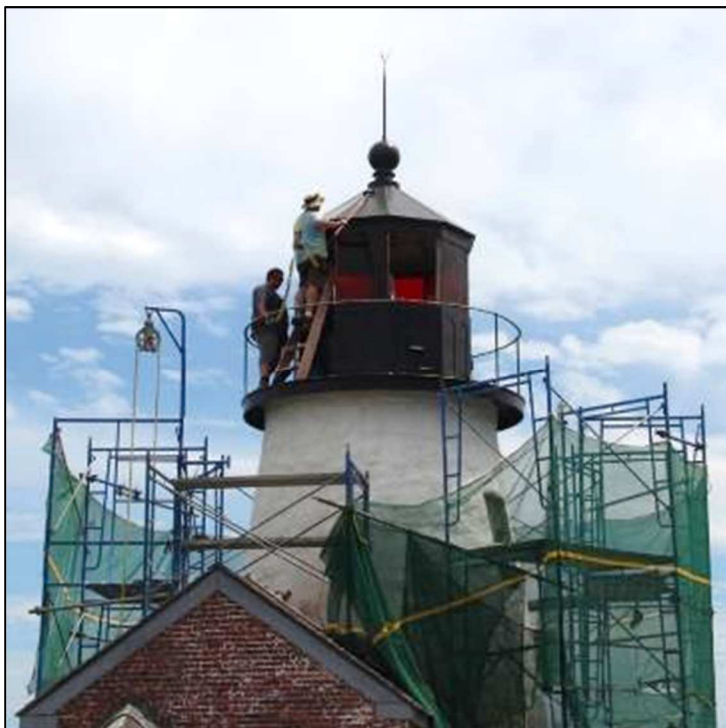
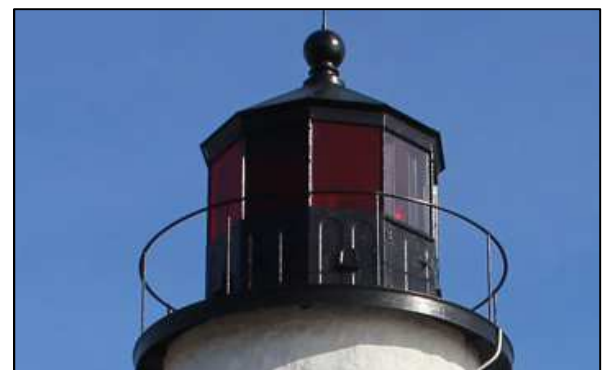
Severe Corrosion

As pictured to the right, roof panels were severely rusted and pitted due to the elements and lack of maintenance.

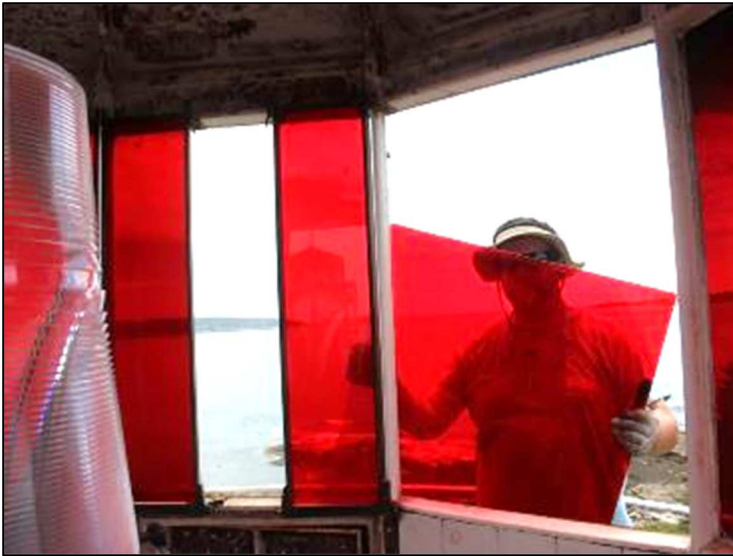
Lantern Glass

The lantern's ten windows were comprised of two clear glass, four historic red glass, and four red plexiglass panels. The original plan was to replace the plexiglass panels with red glass, but unfortunately that didn't happen. Jim Leslie called several glass companies to secure a product that would meet the USCG's color and clarity standards. The three samples subjected to the LED lamp test (Burnt Island's future upgrade) failed after having produced light of unacceptable colors. To keep the project moving forward, the Coast Guard's offer to replace the crazed plexiglass panels at no cost was the best option as countless hours were spent on this venture.

Cracks in two of the historic, red glass panes were stabilized using JB Weld glass and windshield repair epoxy. Clear plexiglass liners have been cut to protect these panes, but attachment method has yet to be addressed.

All old caulking was cut out and metal astragals removed to access window panels. Several of the astragal's screws were damaged or rusted, so they were drilled out and replaced with stainless ones, while those reused were cleaned and repainted.

Once windows were removed, glass pockets and glass stops were sanded and wire-brushed to clean off dirt and rust. All rusted surfaces were treated with OSPHO rust converter, Kem Bond HS primer and black Corothane paint.

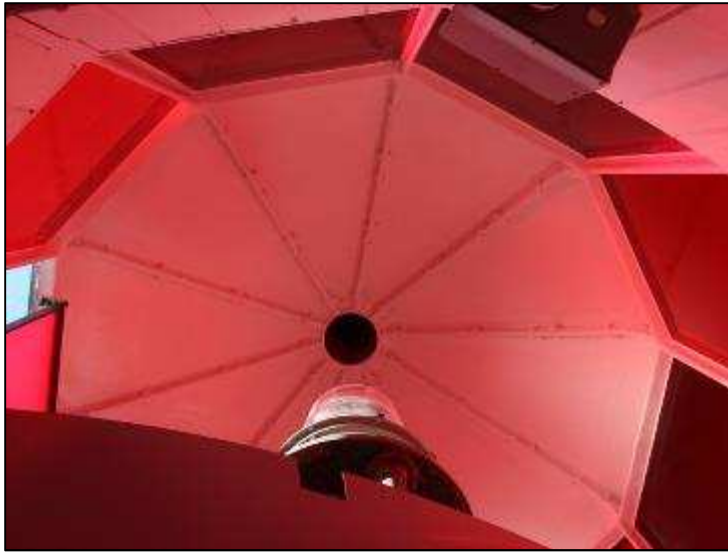
White Sectors

Note the missing panes of plexiglass in the photograph to the left. As work was being performed, the light was never extinguished as all windows were returned before sunset.

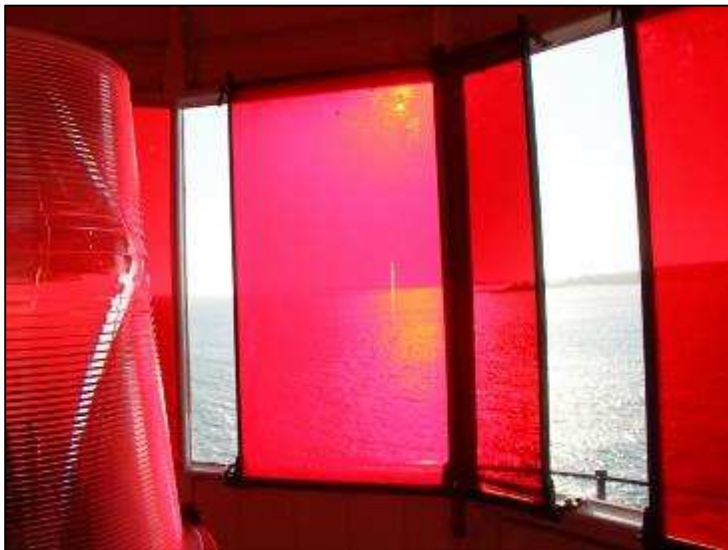
Lantern Interior

The lantern's interior was in decent shape with primary needs being paint and clear windows.

Constructed of cast iron, the ten sections were most likely transported to the site in pieces and assembled on top of the finished tower. The four parts (roof, windows, walls and floor) are all bolted together. The contractor scraped, primed and repainted all surfaces with white paint of commercial grade.

The round hole in the roof of the lantern allows for ventilation. A suggestion is to insert a small fan here as the heat is intense on summer days. Cooler air drawn up from below would also improve air circulation and help solve moisture problems.

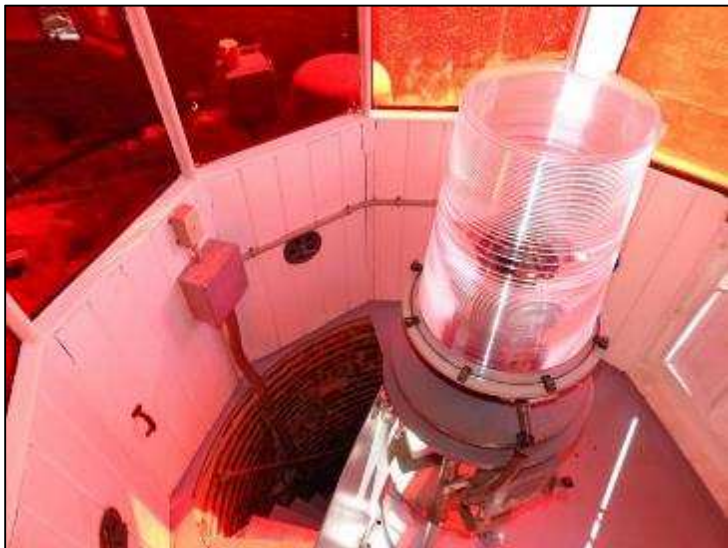
White Sector Panels

The center photo shows the metal framework that holds red glass panels in front of the clear glass panes to form the white sectors. This framework was in good condition as was one eight-inch panel of real red glass. The Coast Guard sent new plexiglass to replace the other two crazed panels, but they were too thick to fit into the framework. Instead, one quarter inch thickness is needed, and that request to the USCG has yet to be made.

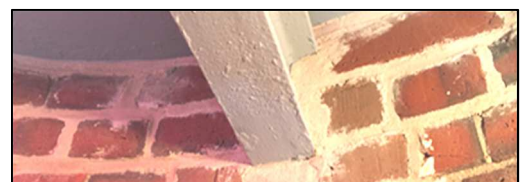
In 1982, when the white sector boards were removed, the brick liner was damaged at their attachment points. As part of the restoration project, similar bricks were cut and mortared in place at those sites. (bottom left photo)

Masonry work also took place at the junction where the lantern rests on the top of the tower. The areas around support beams were reinforced and the top three courses of bricks repointed. These much-needed repairs will help stabilize this interface.

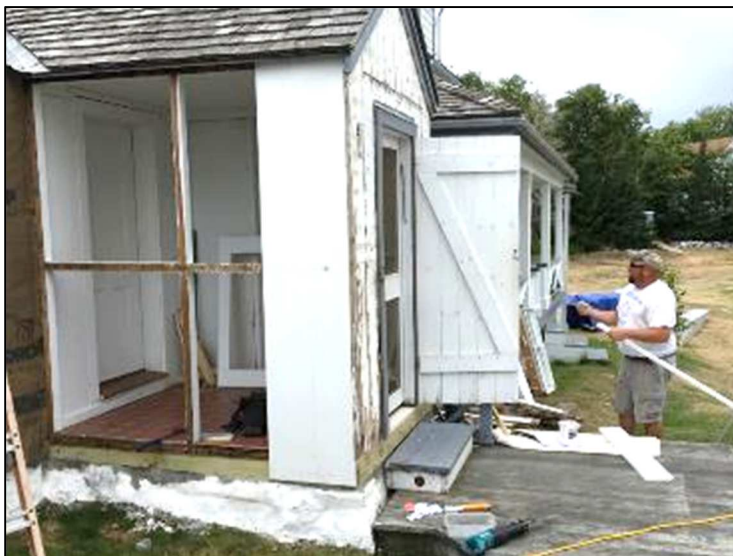
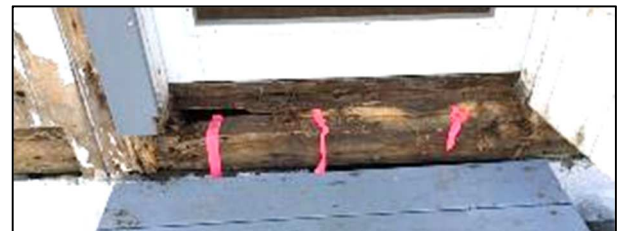
The covered walkway's double sill system was in poor shape with a good 20+ feet of the original sills and floor joists rotted due to direct contact with the ground and runoff water. A cement curb was poured for the new, pressure treated, outer sill pictured above.

The installation of siding was straight forward with eastern white cedar shingles from Maibec applied with a 5" exposure, and radially-sawn, white pine clapboards from Ward Clapboard Mill applied with a 4" exposure. The kitchen's entryway or mudroom received new sills and exterior sheathing of select pine tongue and groove, square-edged, random width (4"- 6"- 8") boards.

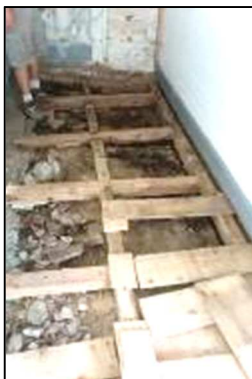
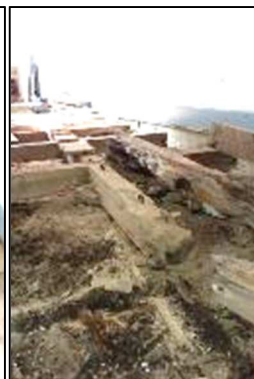
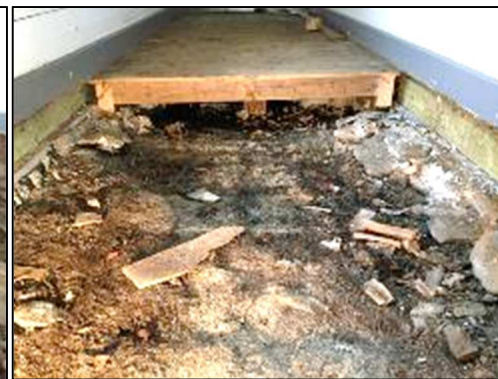
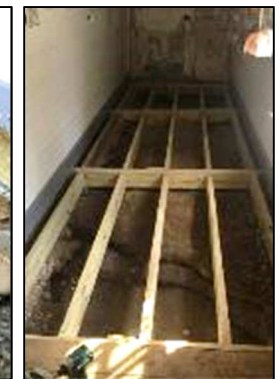
The section of the covered walkway nearest the lighthouse was built directly on ledge, while the section closest to the dwelling was elevated on a granite block foundation. Subjected to 163 years of runoff, sills and floor joists closest to the tower were completely rotted as pictured in the photos to the left.

The larger center photo shows a cross section of the original, double-sill framework with sills supported on stone and 4"x 4" center posts to the ledge below. While scraping the area clean, bones, clam shells, and a raptor's talon were found. So how did they get there? Was it a local mink?

In the photo to the far right, the new floor system consists of 2"x 8" pressure treated cross beams every 6 feet with 2"x 6" pressure treated timbers running parallel to the walls and 16" on center. A subfloor of 7/8" boards covered the framework before the original flooring was nailed back in place using stainless steel.

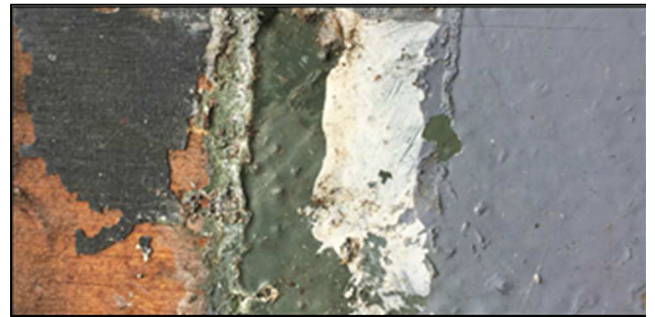
On the left, the charcoal color appears to be the oldest layer of paint and possibly the lead color mentioned in the 1902 instruction manual. In an 1885 photo, the siding and trim were both painted white. However, in a photo taken in June 1895 when the bell tower was being built, the trim was dark. The green trim color was there in 1998 when the property was acquired by the DMR, but was the gray the answer to our quest?

Trim board samples were brought to Mike Johnson at the Historic Preservation Commission in Augusta for analysis. Then, the search began for the true color. A call to Sherwin Williams paint store in Damariscotta led the project manager back to an old friend, one who had already done the research. With the board in hand, she visited Michael Kriendler at the Doubling Point Range Lights in Arrowsic. After comparing the board to his Federal Standard 595 Paint Specification color chips, the gray paint for the restoration's trim was determined to be Federal standard #595-16251.

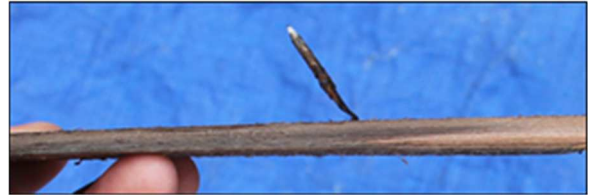
Dwelling Roof

In the early stages of the restoration project, another surprise surfaced when the condition of fascia and trim boards were being assessed. Lead carpenter Marc Holbrook discovered that the roofing shingles were being held on by a thread. Attached with galvanized nails in 2000, the nails holding the white, cedar shingles in place had rusted off. As a result, new roofs had to be included with a change order providing a time extension and the use of the contract's contingency funds for labor, while KBIL paid for all the materials.

Approved for this project was an upgrade in materials to premium Alaskan yellow cedar shingles - 18" long and 5/8" butt. Prior to installation, 40 mil Grace Ice & Water Shield was adhered to the roof boards, topped by CedAir-Mat, a ventilation product used to create an airspace/cavity for air flow. Bostitch 6D, 2" ring shank, 316 stainless nails were used to attach the shingles with 5" exposure. A 2.67" strip of GAF zinc moss and mildew preventer was positioned under the 1"x 6" clear, vertical grain, red cedar, roof cap.

After removing the ridge cap, workers used roofing shovels to lift off the cedar shingles. The sections replaced in front were main roof, porch, ell, and entryway. A one-piece, cedar gutter was replaced along the main roof, while the porch gutter was refurbished as were the two wooden downspouts.

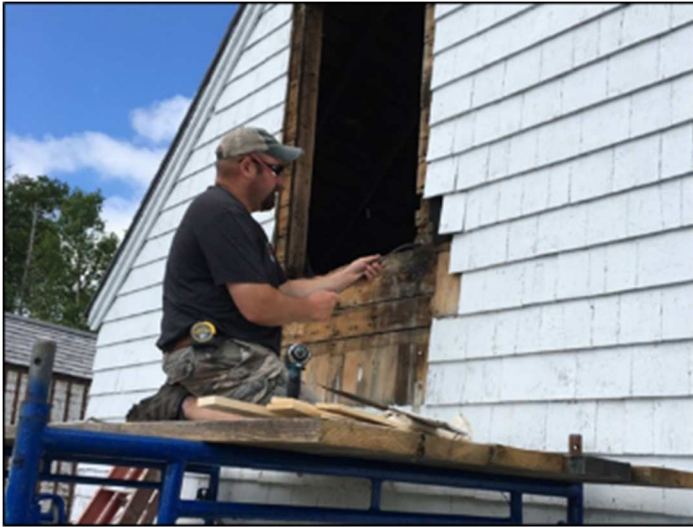
Work Shed

The three windowsills were in terrible condition, so repairs were made before Marvin 6 over 6 windows could be installed. Due to rotten boards, several courses of shingles were removed under the second story window. Some shingles were reused, but others were not as the upper portions had worn thin in the space between shingle overlap. (middle photo)

Adjacent to the house, the work shed's restoration included three new windows, paint, roof, and flagpole. A few years ago, when the pine clapboards were removed, period shingles were exposed. Therefore, all siding and solid trim boards were hand-scraped and painted, while rotten ones were replaced.

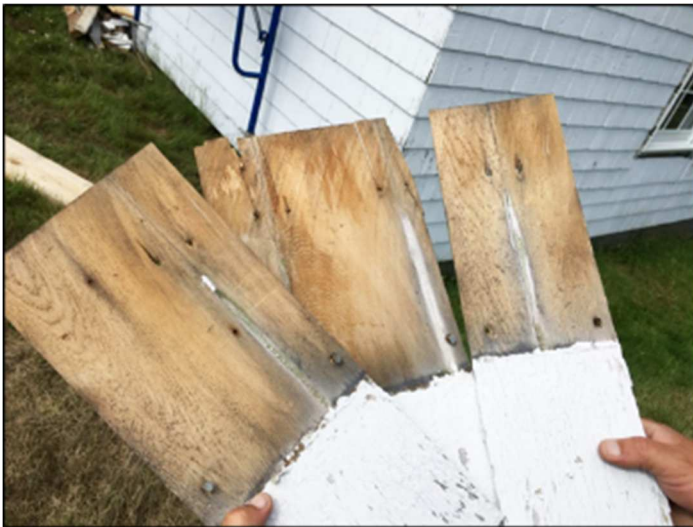
The roof was an add on, as it like the house was destined to fly off due to rusted nails. Materials and labor were covered by the nonprofit group under a separate state contract with carpenter Ted Shorette. Like the house, Alaskan yellow cedar was used with similar application procedures.

The flagpole returned to its historic location at the peak of the shed. A 15-foot wooden pole was sanded, painted, and equipped with the necessary hardware before being topped with a gold ball. Wooden brackets of mahogany were made to attach it above the second story window and to the peak of the roof.
